HydroFORM Liner: A Reliable Fix for Damaged Screens

Region: North America
Customer: Water Systems

Well Type: High-Capacity

Water Well

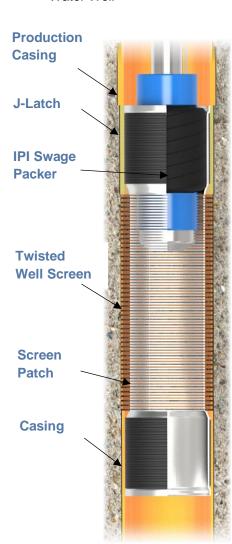
A high-capacity 16in diameter water well relief screen was damaged during initial installation when a drilling contractor used the rig's Kelly drive to install a cone reducer. This caused the J-Latch to disengage, resulting in overtorquing of the riser and twisting of the pressure-relief screen. Though still operational, the screen's structural integrity was compromised, making it unsuitable for long-term use. The damage occurred at a depth of 620 feet, with a static water level approximately 240 feet below ground.

To resolve the issue, a 20-foot custom bridge liner was installed to replace the damaged section. Key aspects of the solution included:

- HydroFORM Liner Design: Constructed using food-grade neoprene vulcanized to Sch10 12" stainless steel pipe and welded to the relief screen. The patch was positioned just below the compromised J-Latch to ensure proper coverage of the twisted screen.
- Pack Installation Tool: An IPI 9.75-inch Swage Packer, equipped with a 30mm Auto Dump Valve (ADV), was used to accommodate the well's static water level.
- In-House Preparation:
 - A 12.75-inch calibration blank was prepared to obtain expected values for installation. The actual installation values were later confirmed to match the calibration valves with ~30 litres per inflation at a setting pressure of 2,300 psi for a full expansion diameter of 15.25 inches.
 - The HydroFORM Liner was shortened from 72 inches to 70.5 inches after swaging.
